the rise, fall & rise

Written and Compiled by Jim Ross

In 2018, the property was purchased by the Route 66 Co-Op, a non-profit formed by like-minded preservationists to save the building from collapse. They secured a National Park Service grant and initiated other fund-raisers. Work by dozens of volunteers began in November 2018, and continued for the next three years.

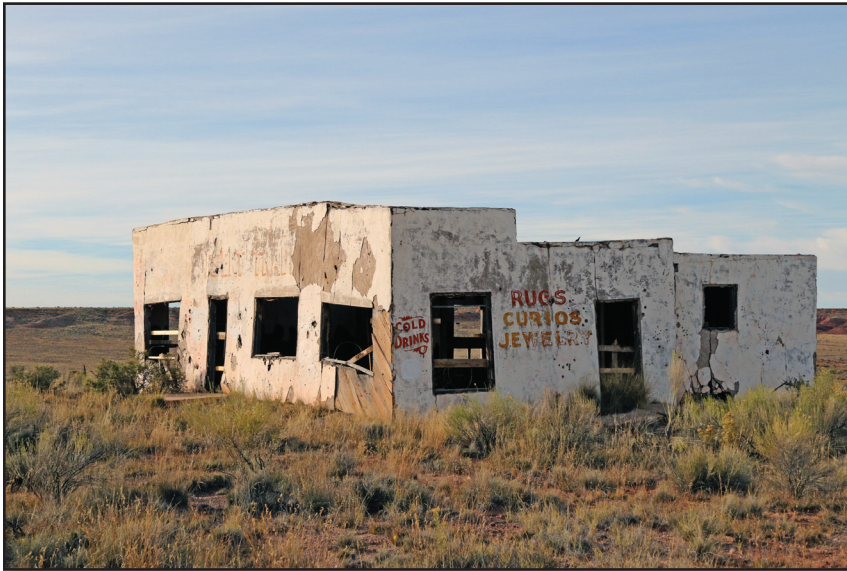
Slumped and bowed walls, a disintegrating foundation, and a rotted roof had brought the trading post to the brink of collapse.

The roof, far beyond repair, would have to be completely rebuilt.

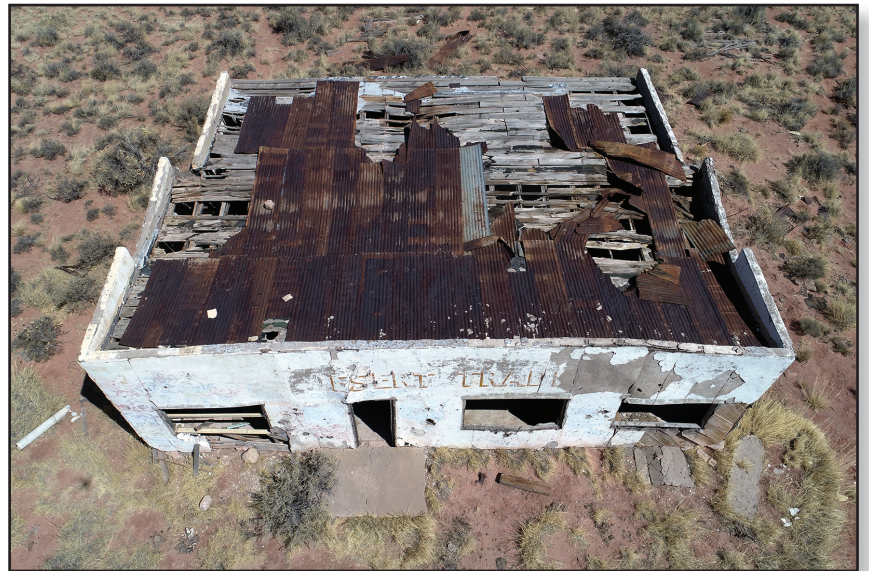
Exposed rafter tails had decayed and window openings were skewed.

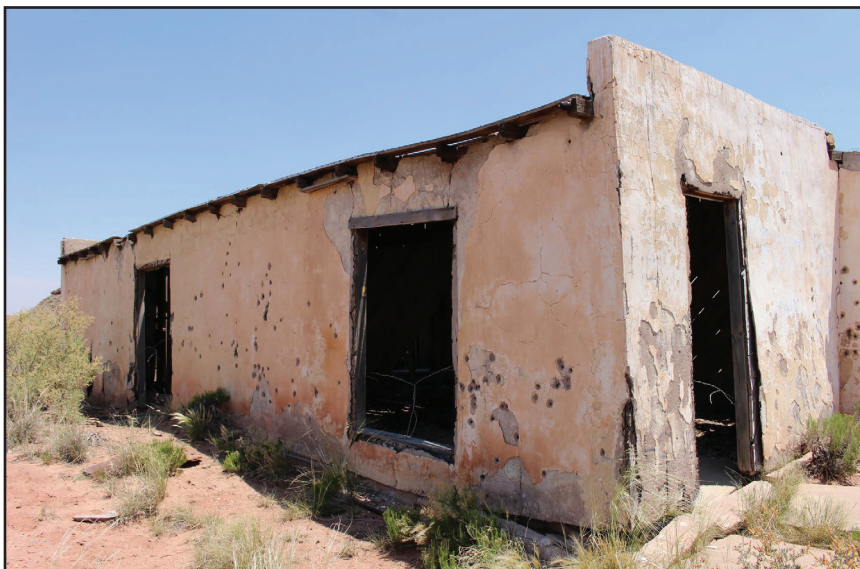
The bottom of the east wall had been pushed out roughly 8" due to the crumbling foundation.

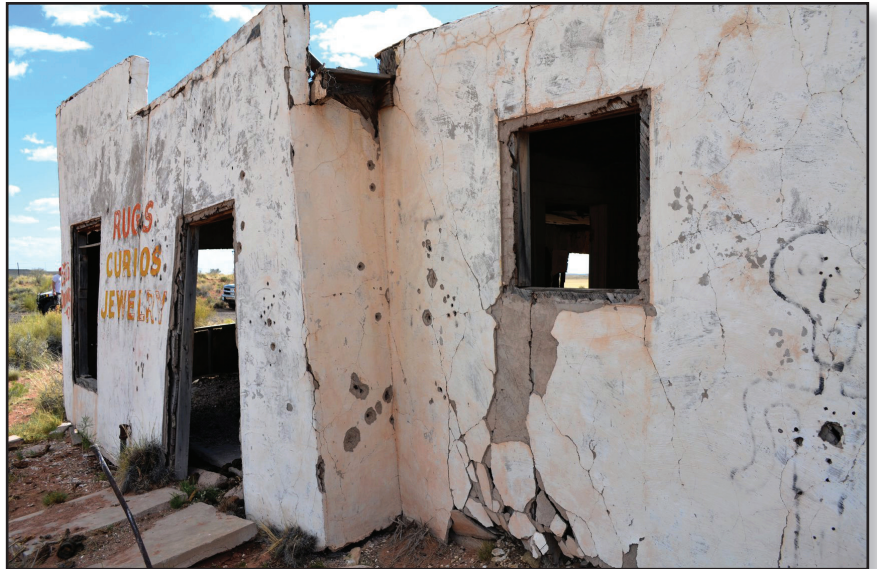
The foundation had completely pulled away from the building's northwest corner.

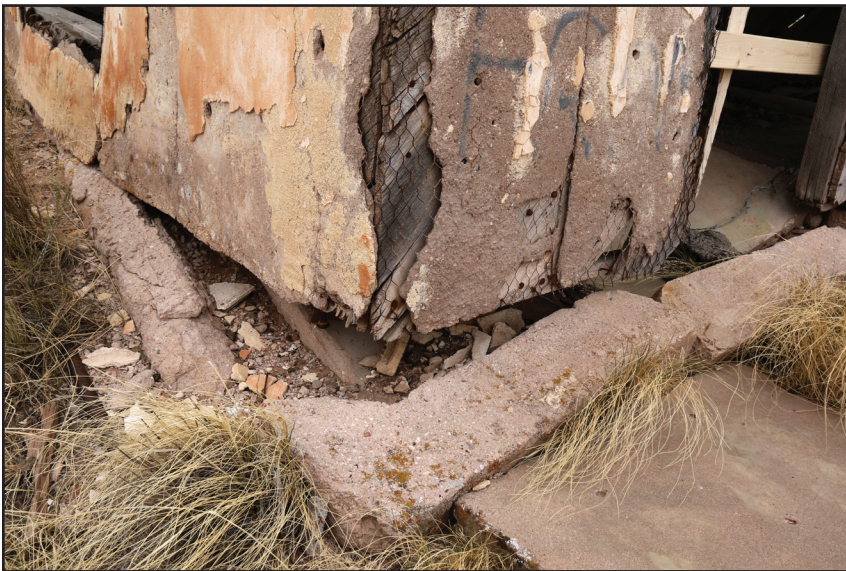
Damage done by cattle had caused large sections of stucco to fall away.

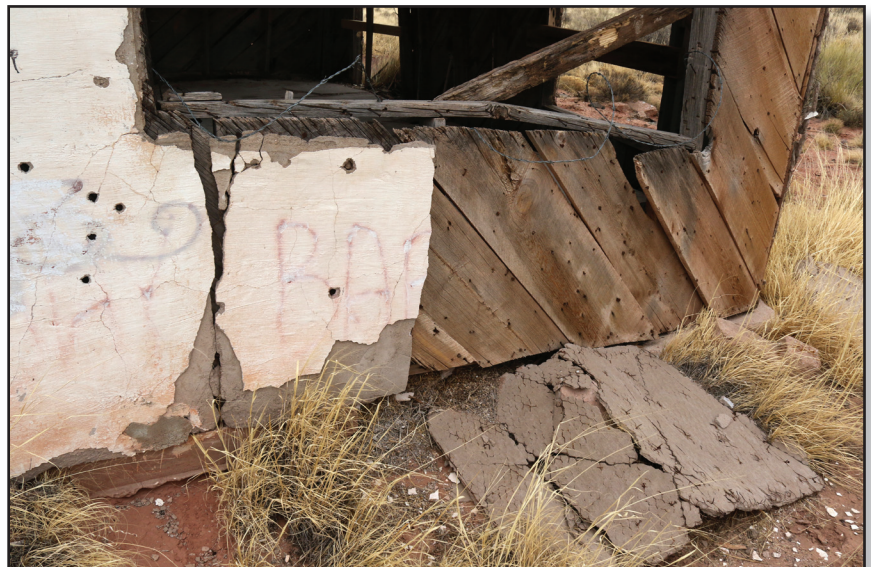
Very little support remained at the northeast corner.

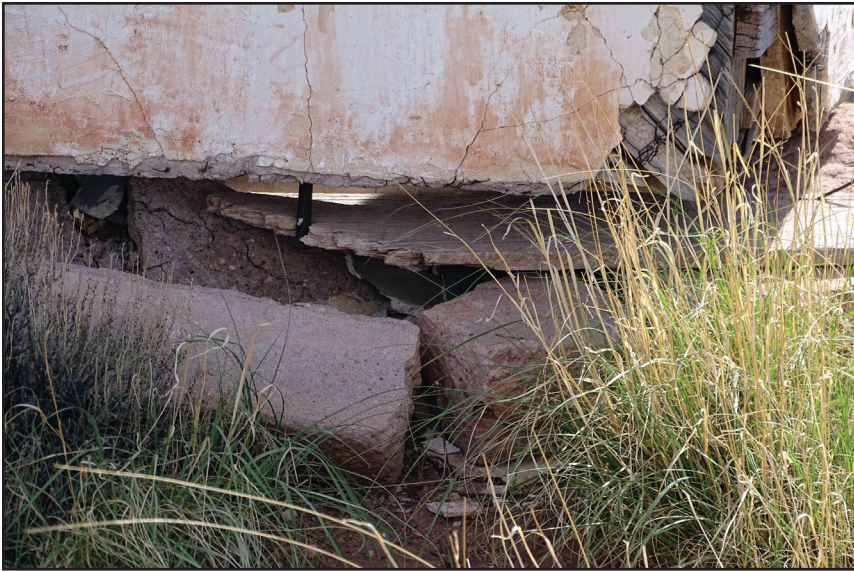
Cattle had destroyed the wall and window opening to the left of the front door.

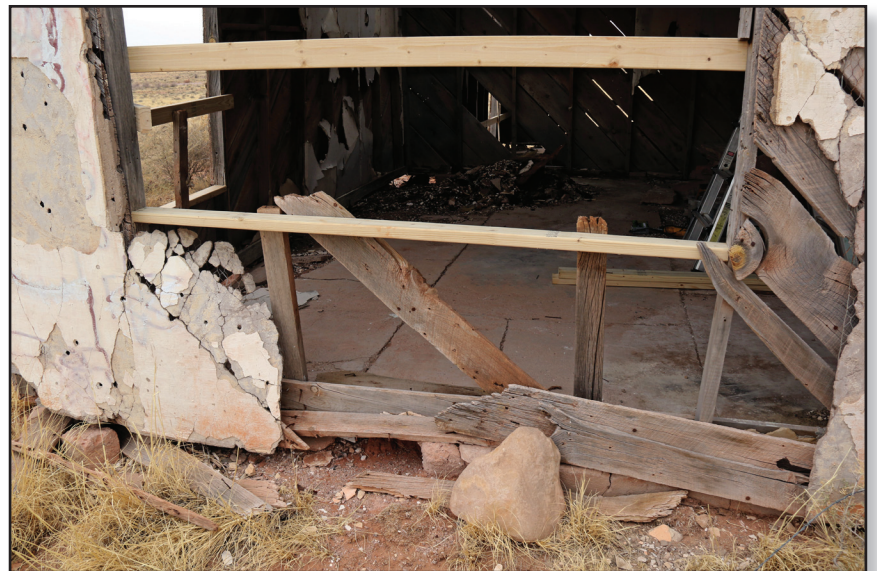
Water coming through the roof caused the sheetrock to fall, which was then pulverized by cattle, leaving a mix of granulated drywall, cow dung, and other debris covering the floor.

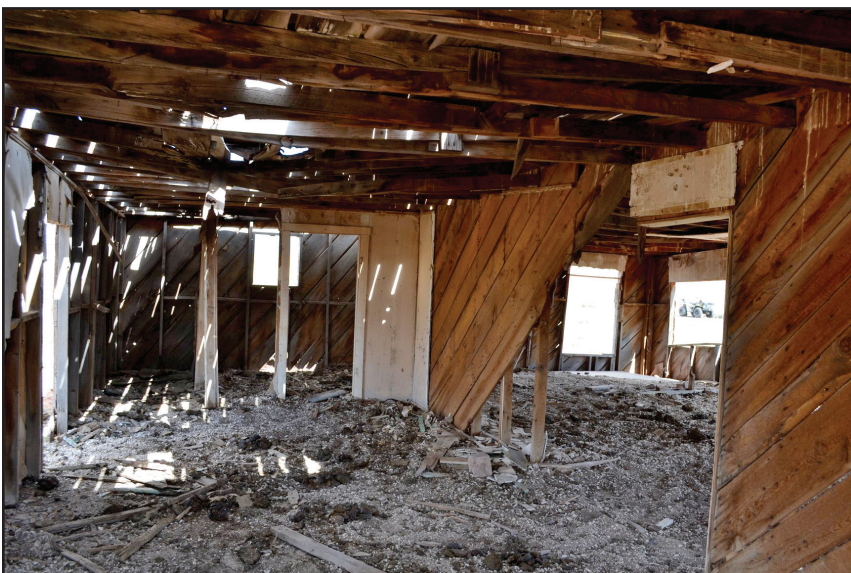
The worst structural damage was at the southeast corner, where the collapsing foundation had caused the walls to drop 16" below the level of the concrete slab.

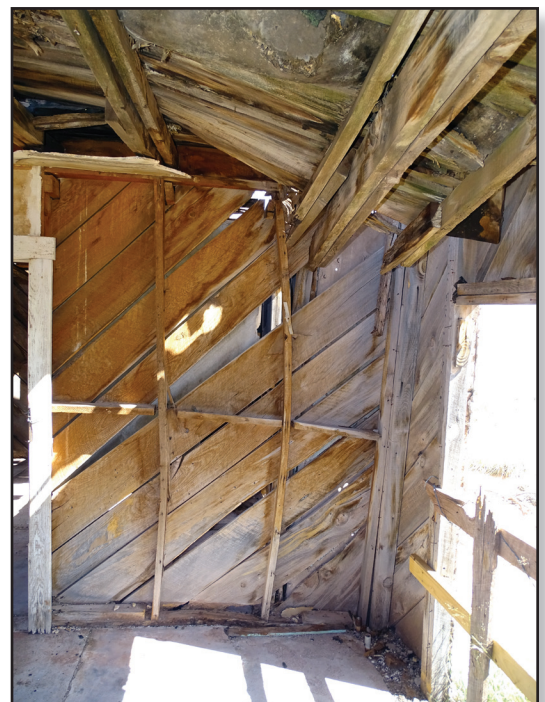
The roof sagged dangerously where the partition wall meets the east exterior wall.

In their NPS grant application, the Co-Op proposed an ambitious approach to stabilizing the building, which would be done in three phases: 1) raise and straighten the walls; 2) completely replace the roof structure; and 3) install a new foundation.

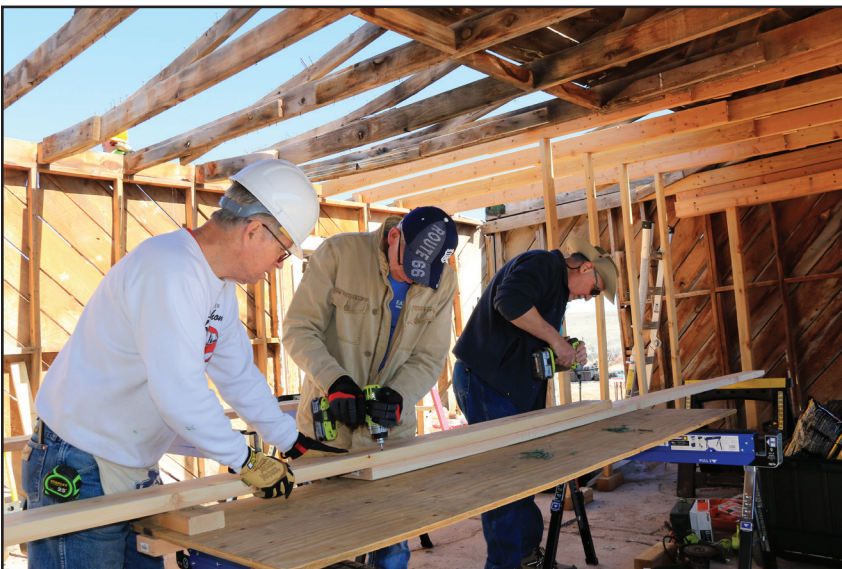
The original rafters were severely deteriorated.
