Reviving a Relic

VOLUNTEERS RESCUE A DEFUNCT TRADING POST
ON HISTORIC ROUTE 66

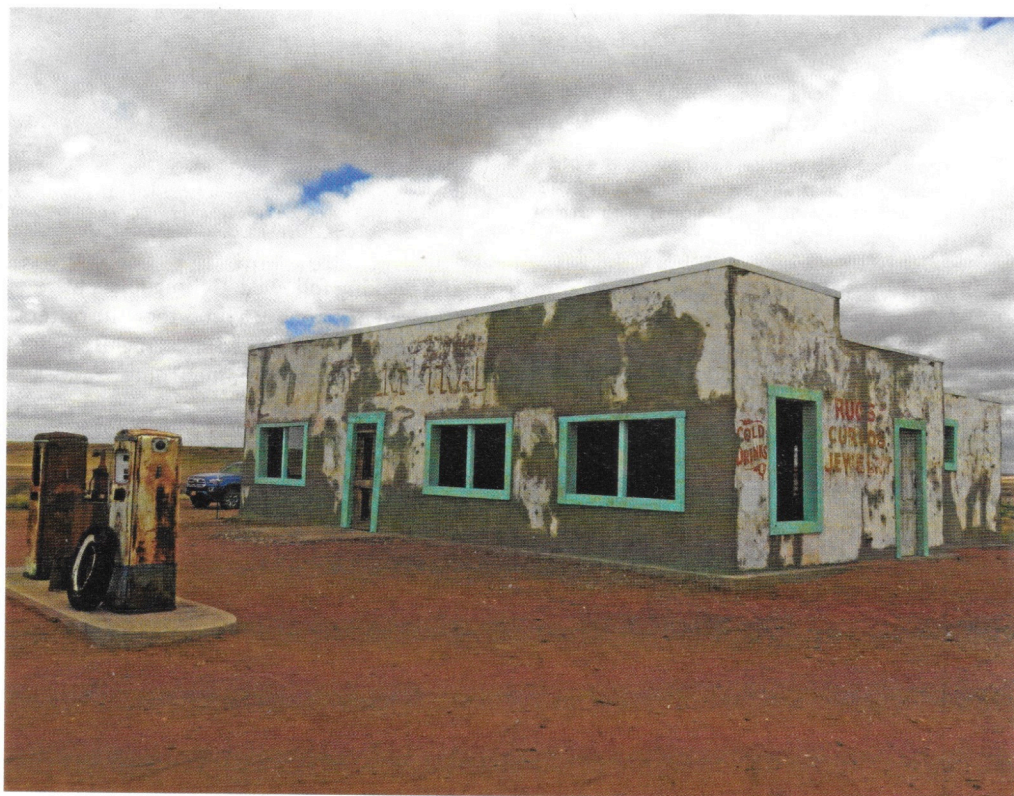
Painted Desert Trading Post in May of 2021, after volunteers repaired the stucco walls (leaving them in a state of arrested decay) and re-created lost window casings.

The goals were simple enough: stabilize the building and manage access for visitors. Executing the tasks needed to accomplish them was not as simple. The structure was seriously compromised, with a sagging, rotted roof and a crumbling foundation, both of which had caused the walls to slump and bulge. Cattle bumping into the building had

done significant damage both inside and out. After consulting with other preservationists experienced in similar projects, the group developed a plan to raise and straighten the walls, replace the entire roof structure, and replace the foundation. No attempt at complete restoration would be made; the trading post was a relic and would remain so.

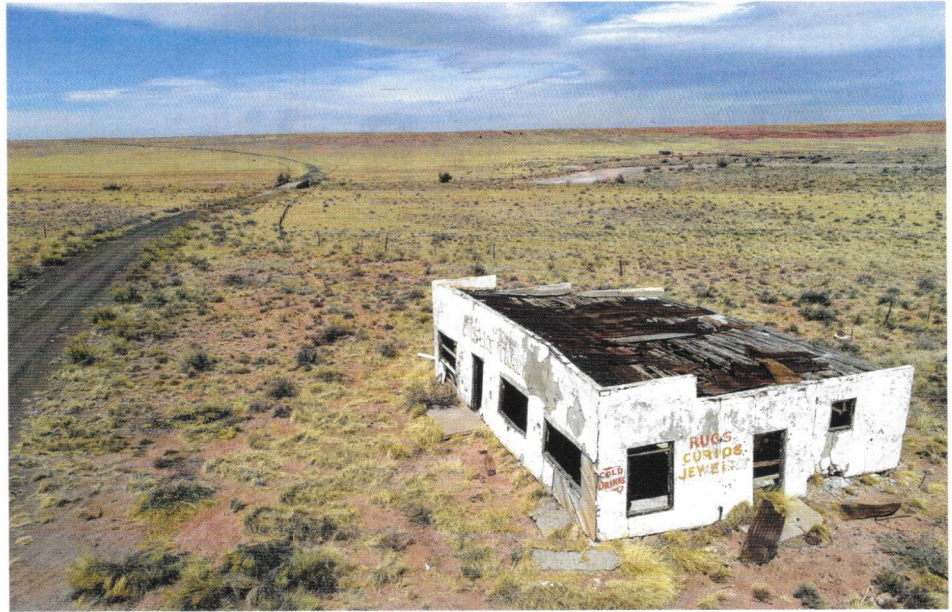
From top left: Workers removing the old roofing; An aerial view of the post in 2018. Historic Route 66 is a National Treasure of the National Trust.

With the walls raised and aligned, removal of the roof's tattered sheet metal

and decking followed. Ceiling joists were replaced next, one at a time, then the rafters. Decking and corrugated sheet metal similar to the old materials came from specialty shops in Albuquerque, New Mexico.
